GEOTECHNICAL ENGINEERING EVALUATION

**The Pines,
Lots 1 & 2, 70 - 74**

**North of Cortaro Road and West of Interstate 10
Marana, Arizona**

**PATTISON ENGINEERING, LLC
Project Number 15-034**

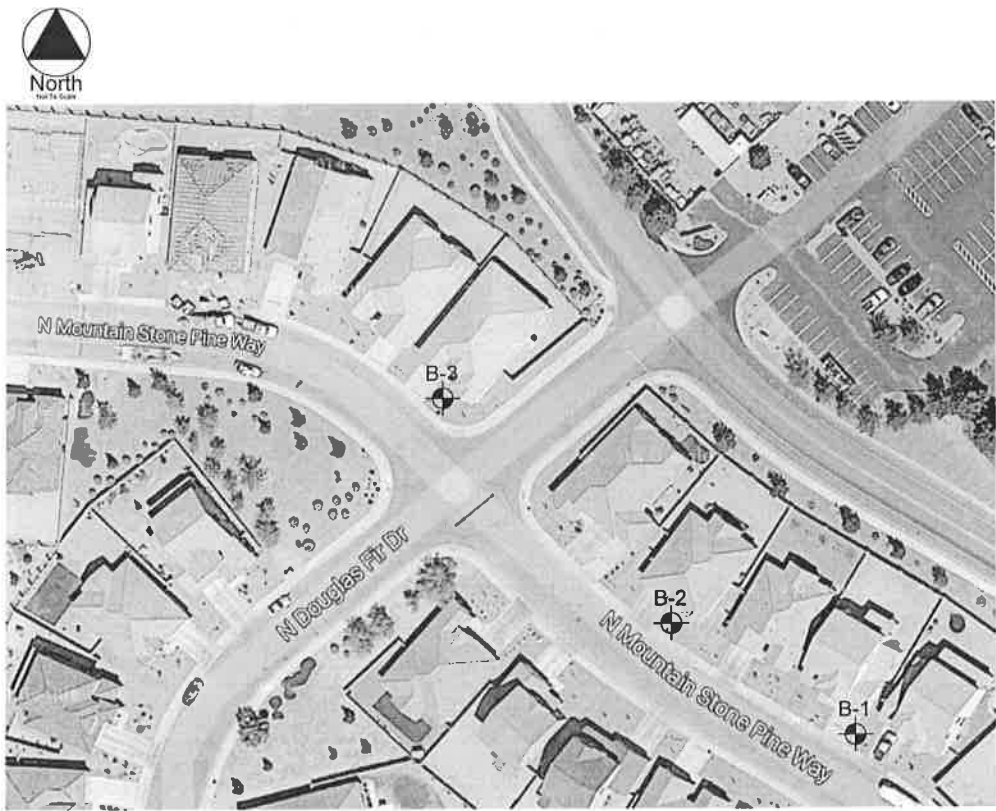
Site and Exploration Location Plan

BORING LOCATION
